CONFIDENTIAL DBCE DOC 91/79(M)

**REVIEW OF DOMESTIC ASBESTOS  
PROGRAM FOR  
ACT DEPARTMENT OF URBAN SERVICES**

S.K. Brown & A.K. Martin

August 1991

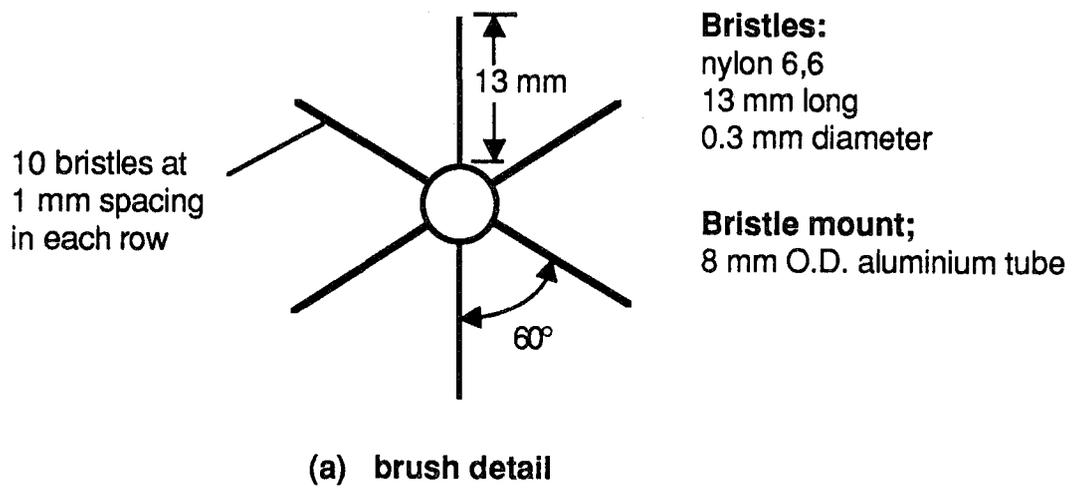
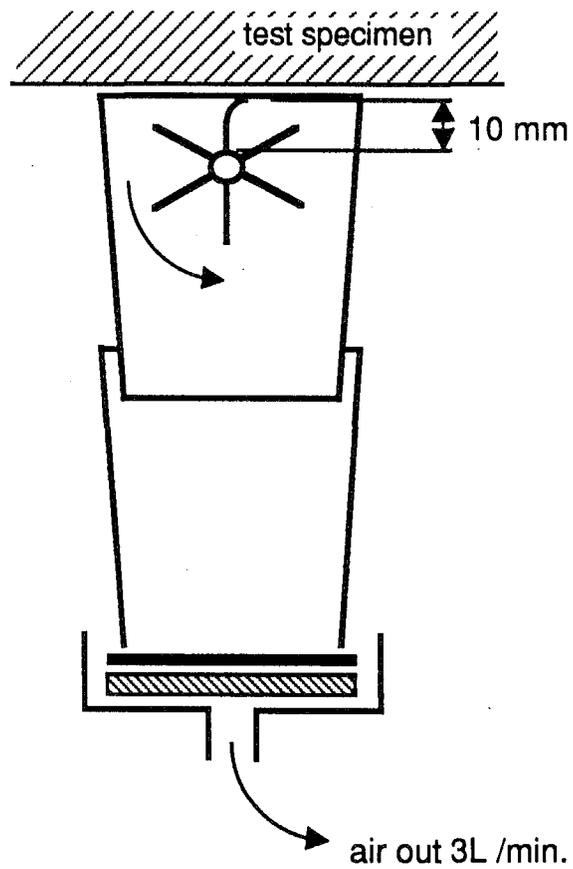
Figure 1. Brush erosion test device

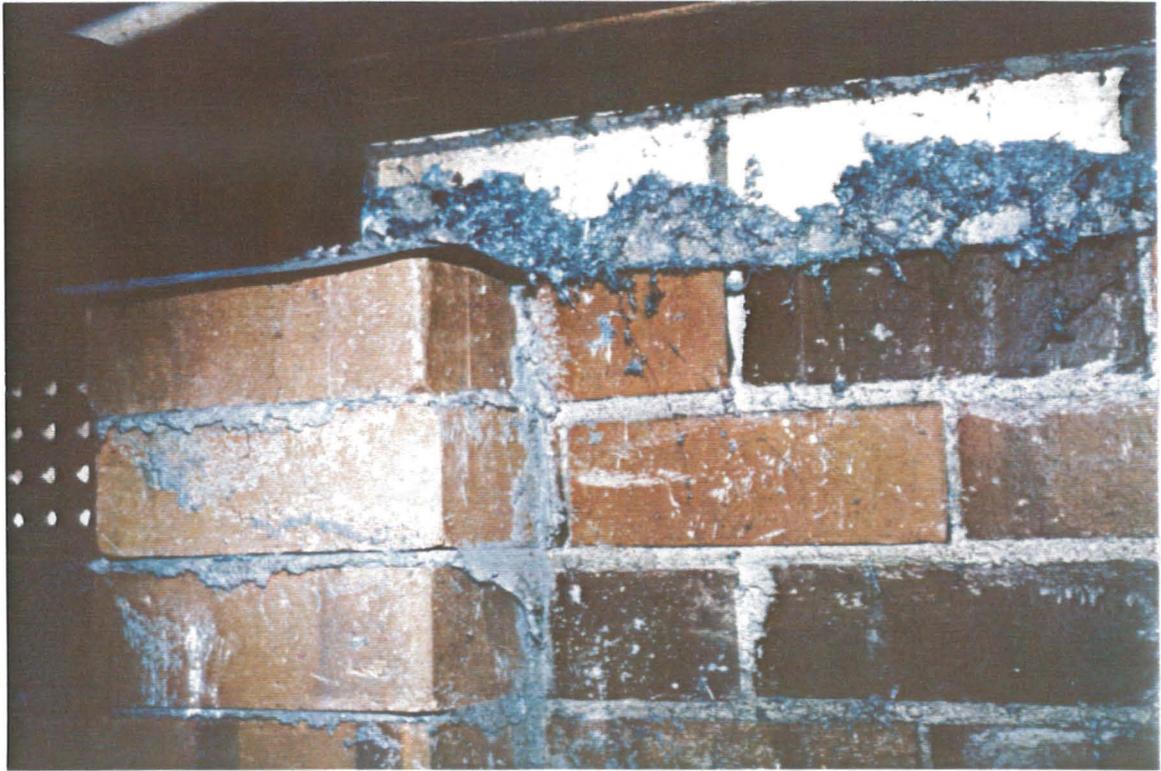
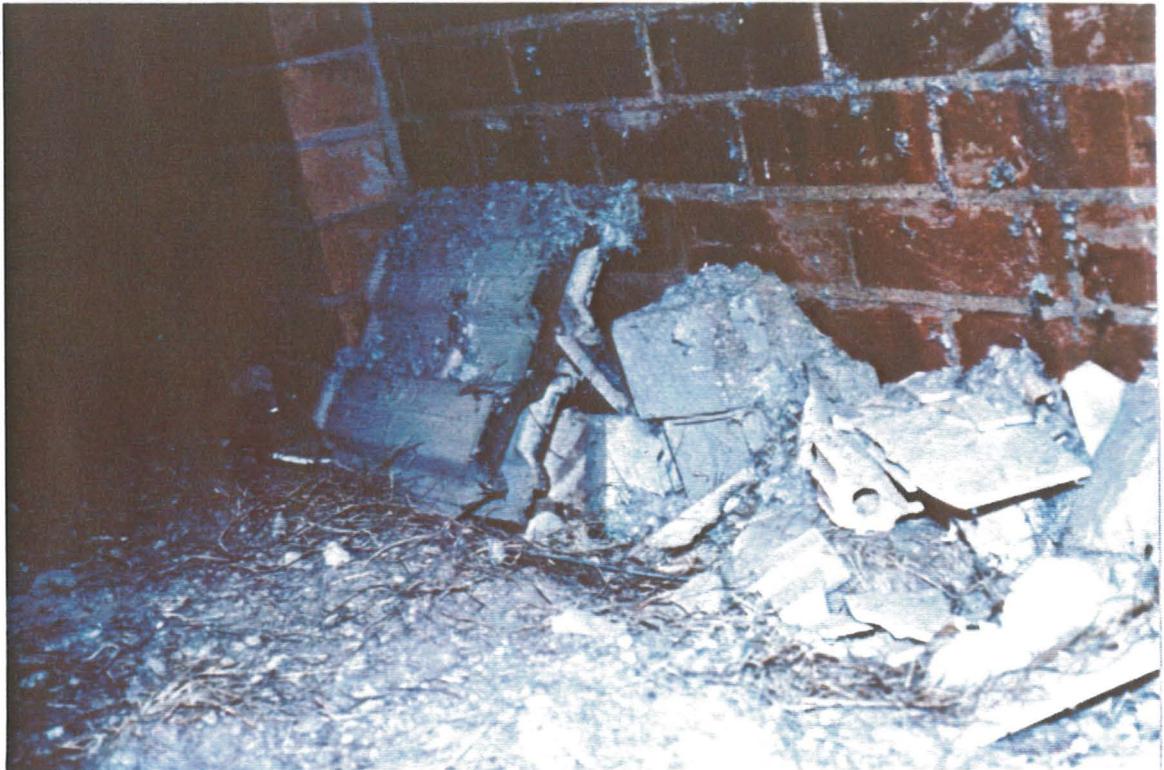
Results from inspection of sites 1 to 4 and analysis of residues are summarised in Table 1. The sites showed little or no evidence of coating with sealer when assessed by the appearance of building surfaces and the friable nature of asbestos residues. All sites showed asbestos contamination at most locations inspected although with wide variation in the quantity of residues. In general the external walls contained greatest quantities of asbestos. Asbestos in these external walls occurred as pieces attached to mortar dags and wall ties and as bulk material collected onto wall noggings. In one case this had led to substantial bulk asbestos falling down into the sub-floor space (Figure 2). Ceiling joists, battens and plasterboard were less contaminated than the roof beams (trusses, tile battens etc.) above them, possibly as a result of previous asbestos removal activities. At site 2, the asbestos residue on the top of roof tile battens and undersides of tiles was extensive (Figure 3) and it was considered possible for this material to fall down to lower areas and add to their contamination.

Figure 2. Bulk asbestos fluff residues in subfloor space of site 3.

Inspection of 4 pre-program removal houses found that significant quantities of unsealed asbestos remained in the ceilings, external wall cavities and sub-floor spaces. Such buildings should be considered as highly contaminated with unsealed and friable asbestos in relation to future entry of maintenance workers into ceiling or sub-floor spaces or future building alterations. They do not meet the specification of the Domestic Asbestos Program that all visible and accessible asbestos should be removed and that residual contamination should be adequately sealed. While these ceilings were not entered by DBCE Officers in order to determine potential for personal asbestos exposure, it is considered probable that such entry by maintenance workers would entail unacceptably high exposure and clothing contamination. It is concluded that pre-program removal houses should be included in the current Program if they are to meet its specifications.

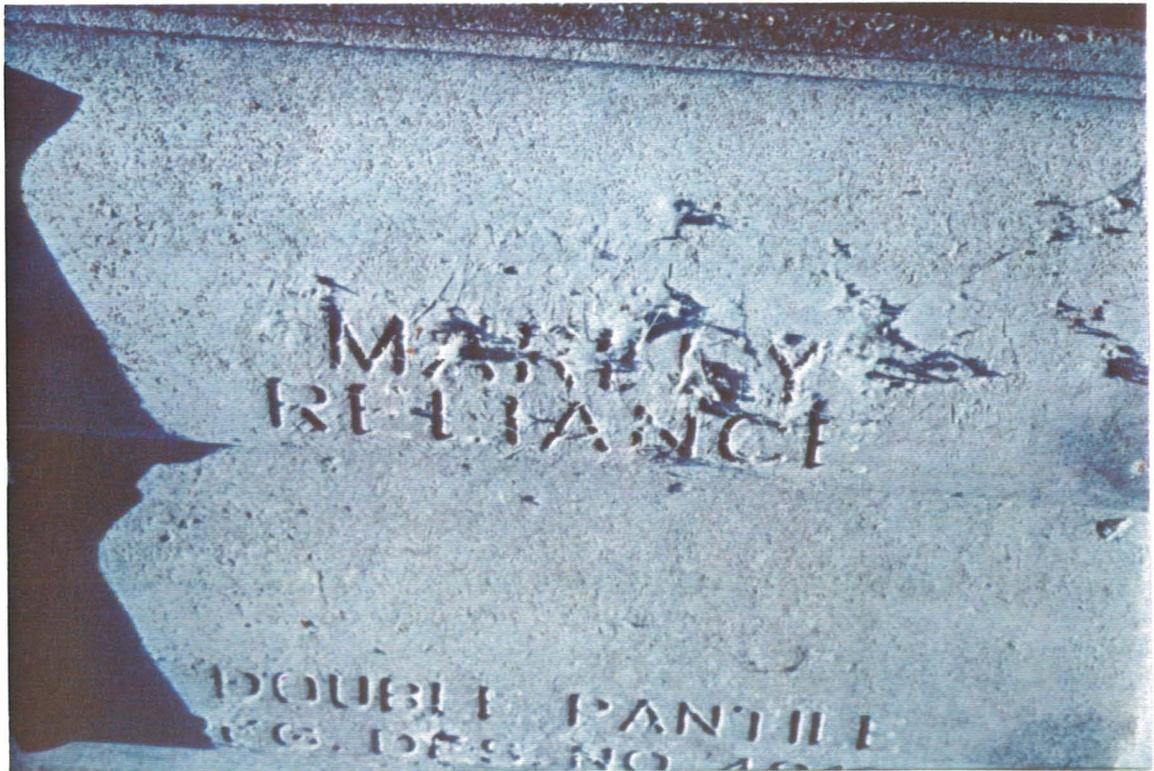
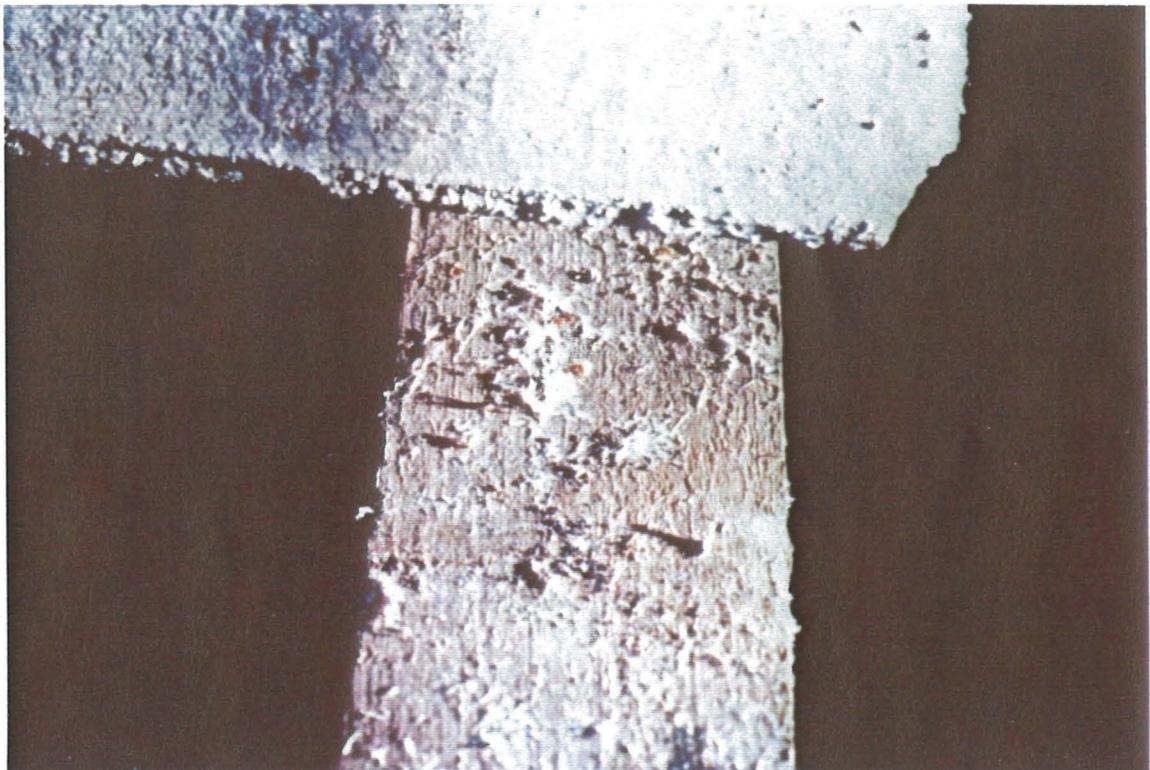
- 7.2** Asbestos fluff residues in pre-program removal houses occur on the under-sides and laps of tiles, on the top of tile battens, on most surfaces of structural timbers and in external wall cavities, all of which are locations from which asbestos fluff would be difficult to remove without the complete removal of tiles as occurs in the current Program.

Figure 3. Layer of asbestos fluff residues on underside of tiles and on top of tile battens at site 2.

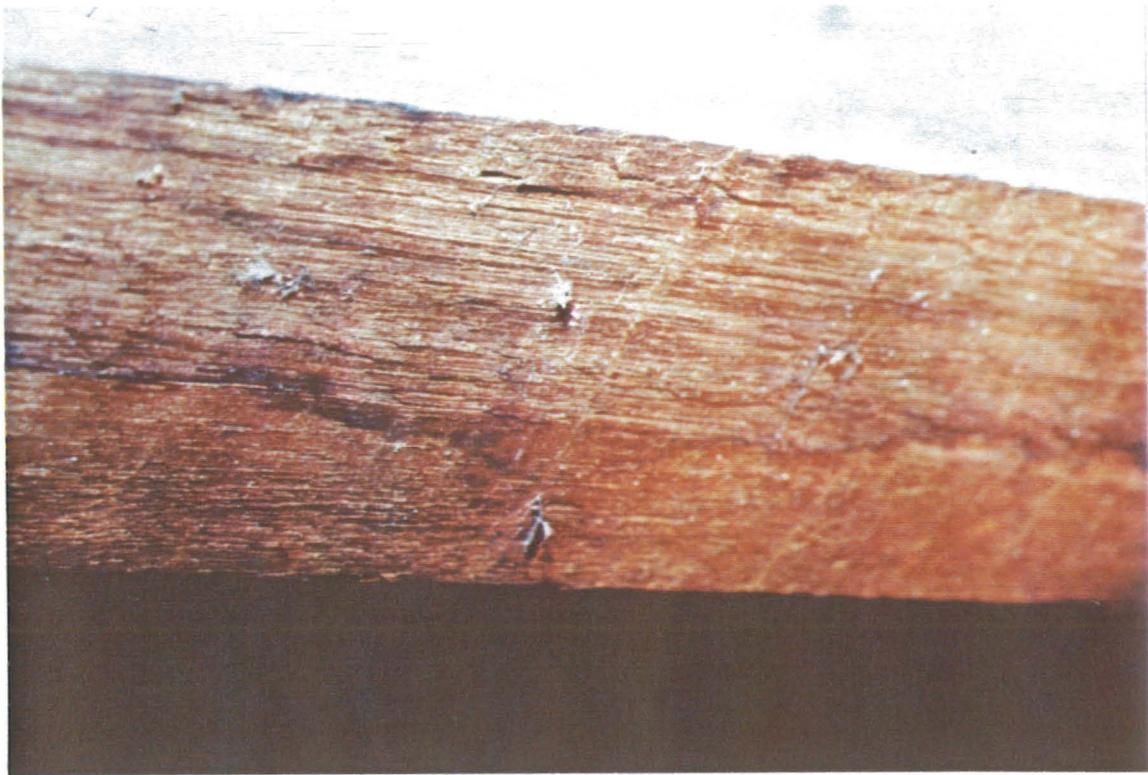
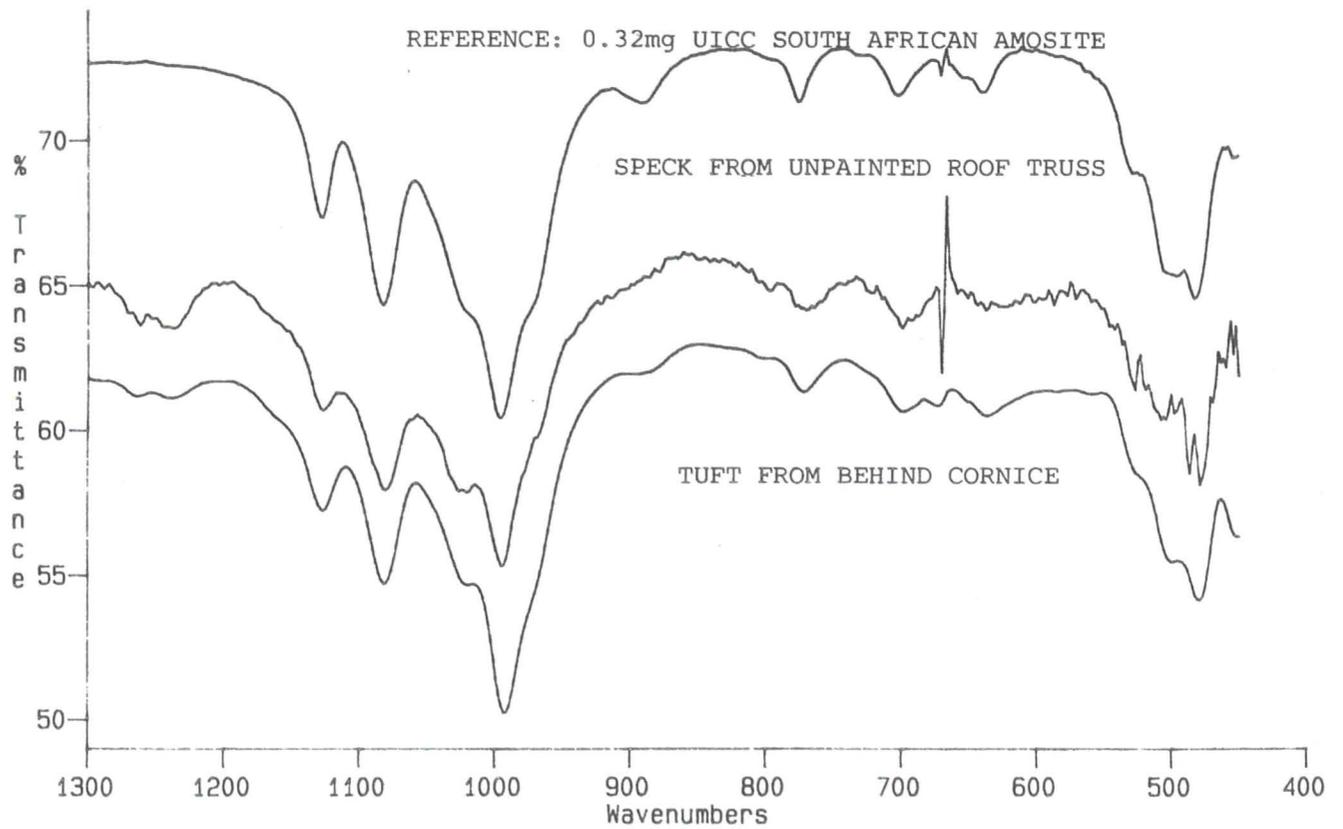
Other asbestos fluff residues found in the ceilings were generally trace amounts of specks and small tufts of residue remaining on timbers that had no sealer applied (Figure 4). Six of the seven sites inspected were found to have incomplete sealing of timber surfaces (Figure 5), generally the undersides of rafters and trusses and the sides of ceiling battens, but in some cases including the

Figure 4. Specks of asbestos fluff residue on unsealed underside of roof truss and infrared spectra of residues from Program removal sites.

- (b) binding of asbestos traces by applying sealer to all timber and other surfaces in the ceiling space.

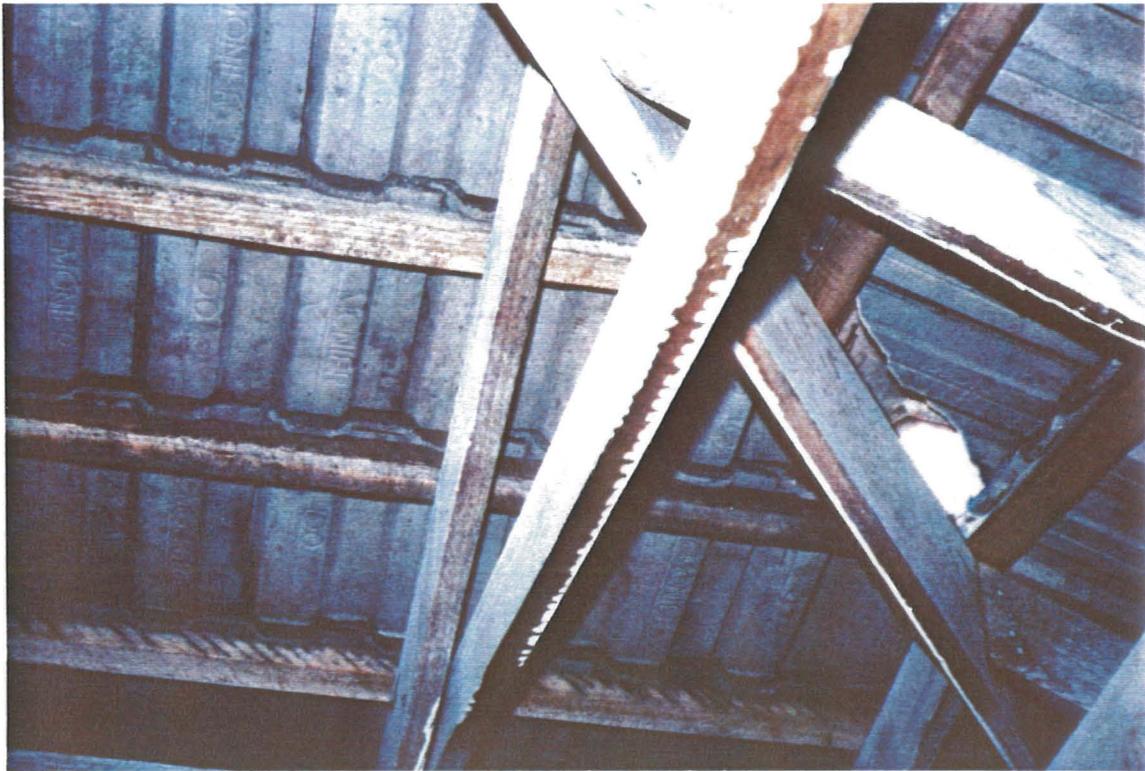
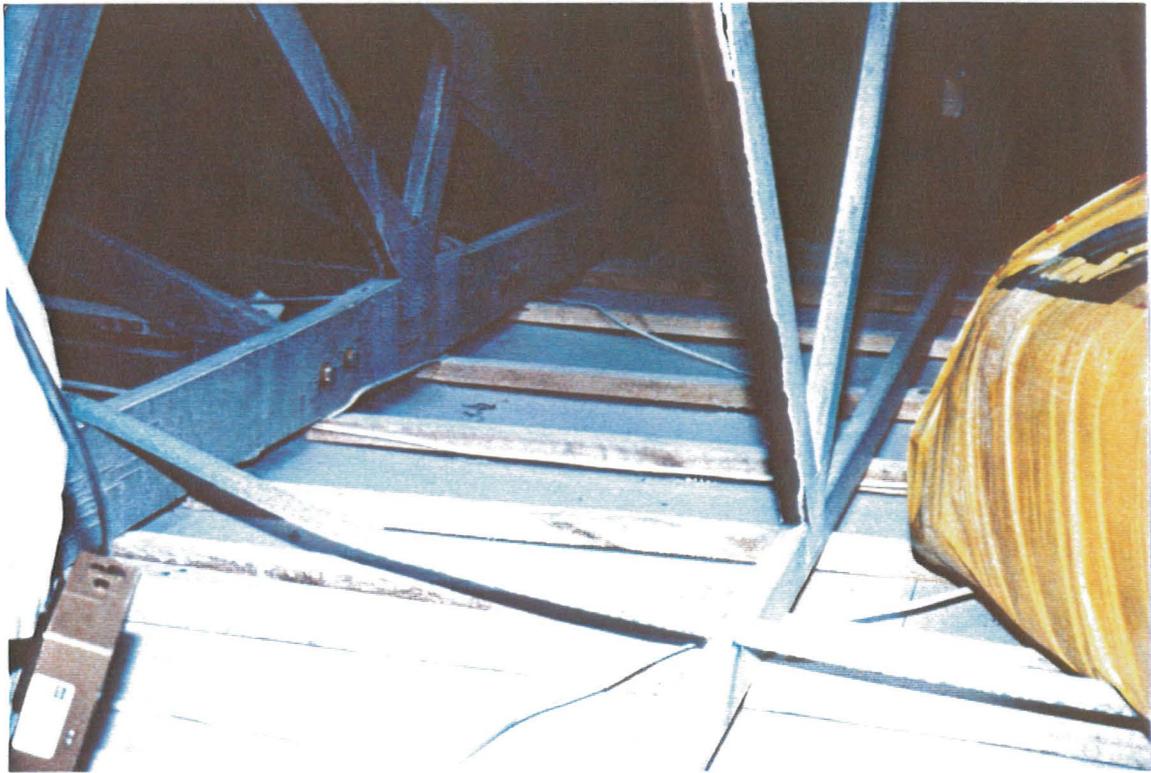
sides of rafters and ceiling joists. In contrast, the sealer appeared to be more completely applied to external wall cavities, eave areas, ceiling surfaces and subfloor spaces.

Figure 5. Incomplete sealing of ceiling space timbers at Program removal sites.

- 7.4** The stringent specifications of the Domestic Asbestos Program have been met with high degrees of cleanliness being achieved in most of the locations that were inspected. However the specifications were not fully met in two locations. Inspections should be extended to ensure that asbestos fluff residues are removed from internal walls and that sealer is applied to all surfaces in the ceiling spaces.
