Asbestos Survey Report for the Food Science Australia Property at Cannon Hill

Food Science Australia

PPK Environment & Infrastructure Pty Ltd

April 2000 84M071A-PR002Apc

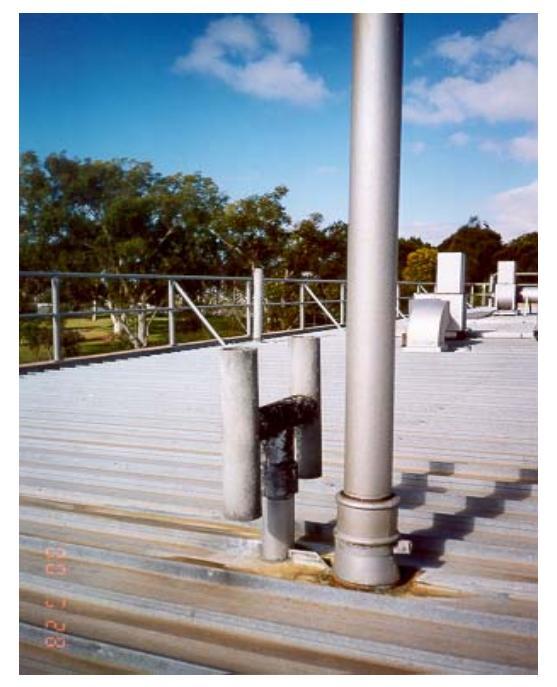
Photograph 1:

| Sample No | Level | Room | Location | Material | Application | Cond. | Sealed | Size | Asbestos Type | Risk | Photo |
|---|---|---|--|---|---|---|---|---|---|---|---|
| FS047 | Roof | External | North side of roof access shed | Fibre cement pipe | Flue pipe | Fair | No | < 1m ² | CH,A | Low | 1 |
| Additional Comment | H section or | n top of flue pip | e. | | | | | | | | |

Asbestos cement "H" section of flue piping on the roof of Laboratory A. A second asbestos cement flue pipe can also be seen in the background.

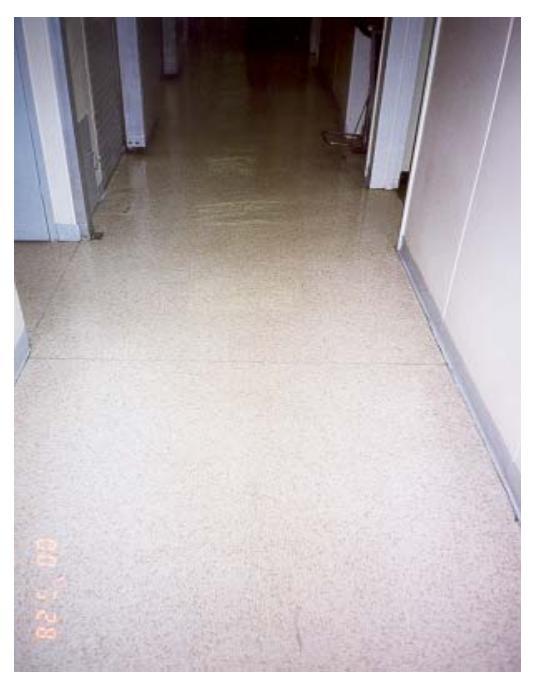
Photograph 2:

| Sample No | Level | Room | Location | Material | Application | Cond. | Sealed | Size | Asbestos Type | Risk | Photo |
|---|---|---|--|---|---|---|---|---|---|---|---|
| FS048 | 1 | Main corridor and two side corridors | Throughout | Vinyl sheet backing | Floor covering | Good | Yes | 55m ² | СН | Low | 2 |
| Additional Comment | White and fa | awn fleck colou | ir. | | | | | | | | |

Asbestos backed vinyl sheeting located in the central corridor and two main side corridors of Laboratory A. Similar type vinyl sheet was identified in the lunchroom of Administration Block C.

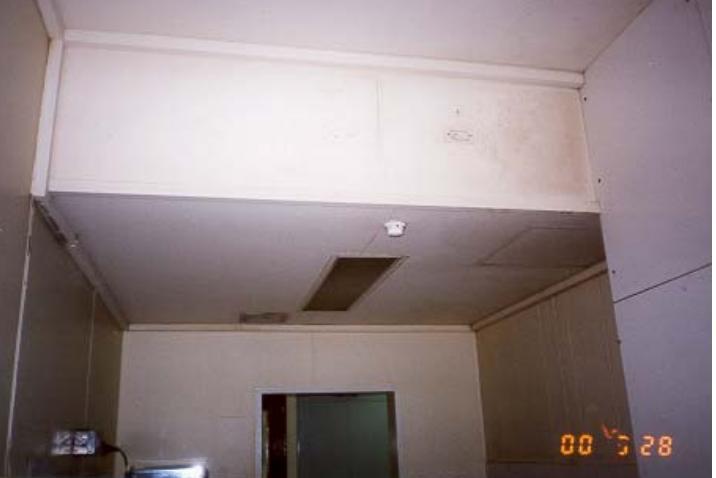
Photograph 3:

Asbestos cement bulkhead on southern side of ceiling of Room 112 in Laboratory A

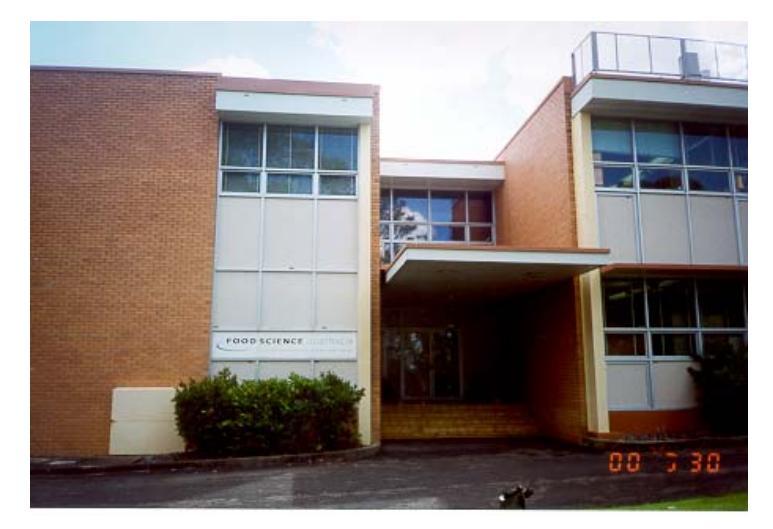
Photograph 4:

| Sample No | Level | Room | Location | Material | Application | Cond. | Sealed | Size | Asbestos Type | Risk | Photo |
|---|---|---|--|---|---|---|---|---|---|---|---|
| FS064 | 1-2 | External | Southern and northern wall of laboratory A wing | Fibre cement sheeting | Infill panel | Good | Yes | 145m ² | CH,A | Low | 4 |
| Additional Comment | Labelled wit | th asbestos warr | ning labels. | | | | | | | | |

Asbestos cement infill panels, and vertical fascia panels identified with asbestos warning labels along the southern walls of Laboratory A and Administration building. Asbestos cement eaves lining on the second floor of Laboratory A and soffit linings on the second floor of the administration building can also be seen.

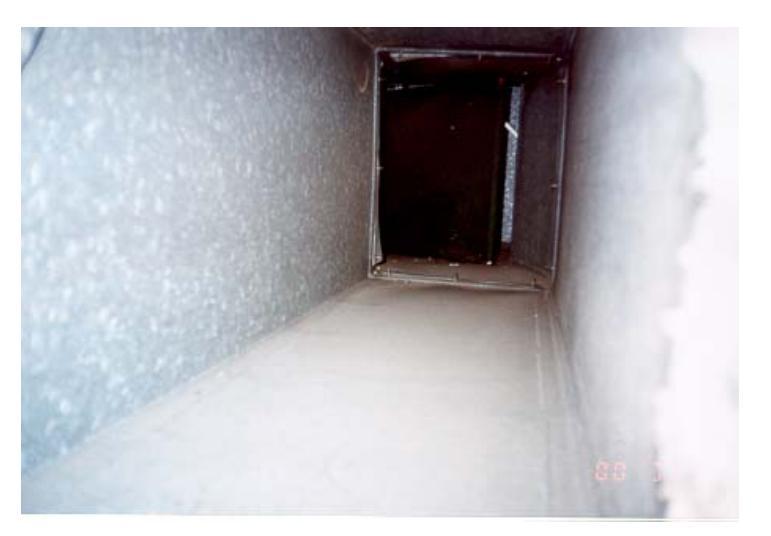
Photograph 5:

Asbestos millboard debris located in the supply air ductwork in the bulkhead on the western side of room 147 on level 1 of Laboratory B. The extent of the contamination is unknown and could extend further along the ducting.

- 1. Remove the asbestos millboard and residual asbestos around the heaterbanks and along ductwork as soon as possible. The asbestos removal work should be undertaken by licensed asbestos removal contractors under the supervision of an experienced occupational hygienist;

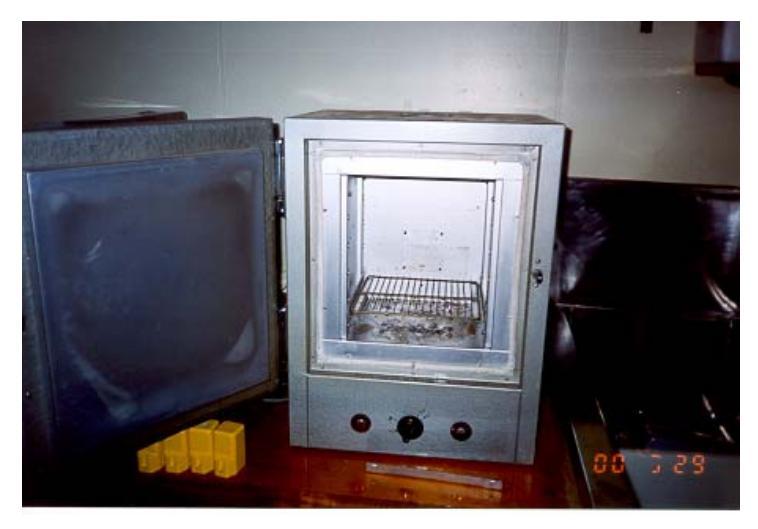
Photograph 6:

Asbestos rope seal to "Labmaster " oven in south western corner of Room 147 on level 1 of Laboratory B.

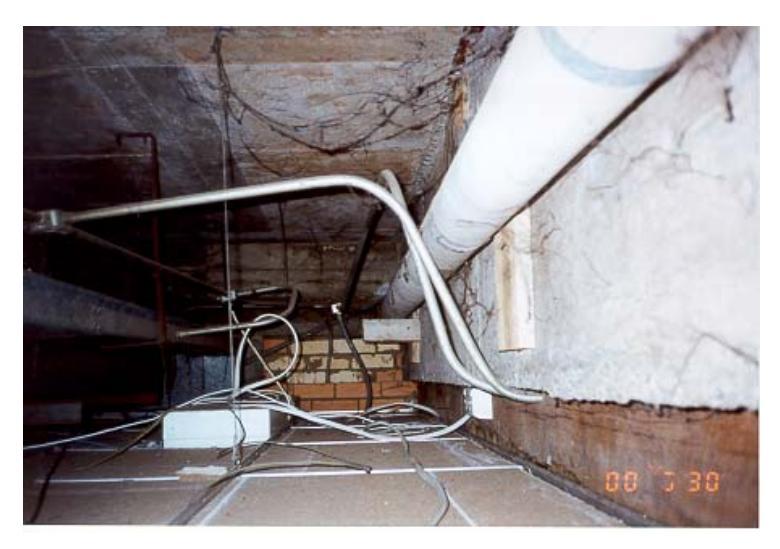
Photograph 7:

Redundant asbestos cement pipe running along the southern wall in the ceiling space of the Reception area of the Administration Building.

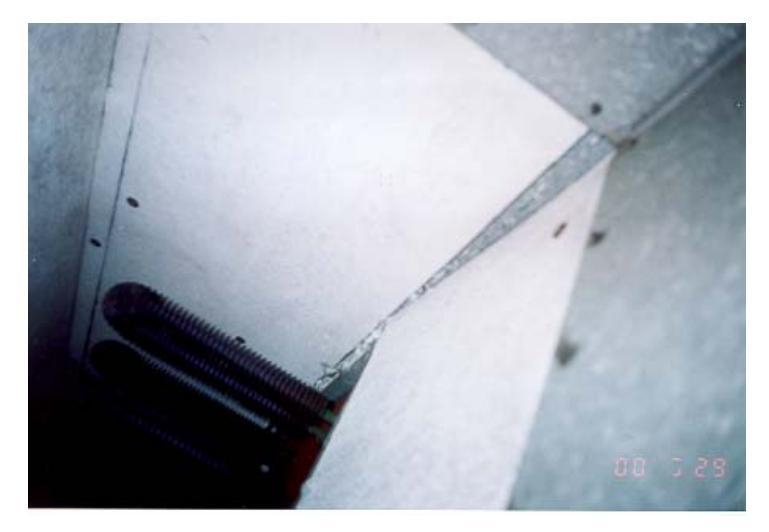
Photograph 8:

Residual asbestos millboard around heaterbank in A/C ducting (closest to the double doors) on the southern side of the plant room of the administration building.

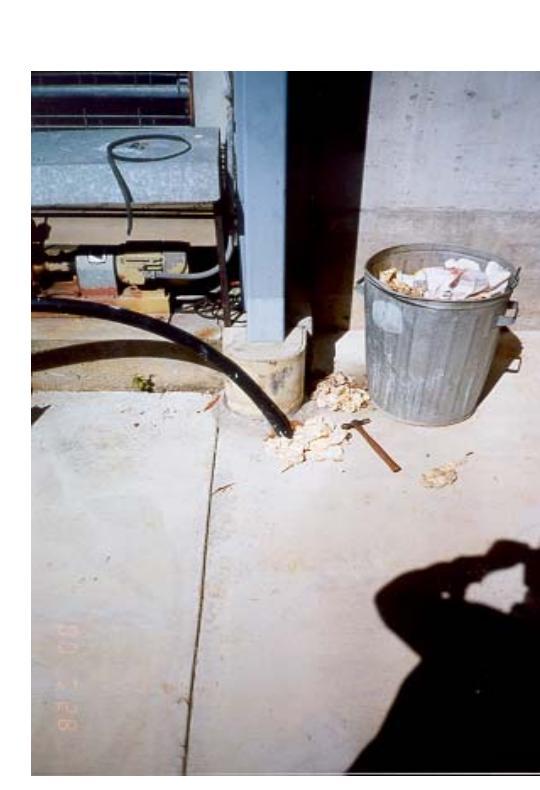
Photograph 9:

Asbestos cement casting of the downpipe collar adjacent to the holding yard on the western wall of the Meat Research Laboratory

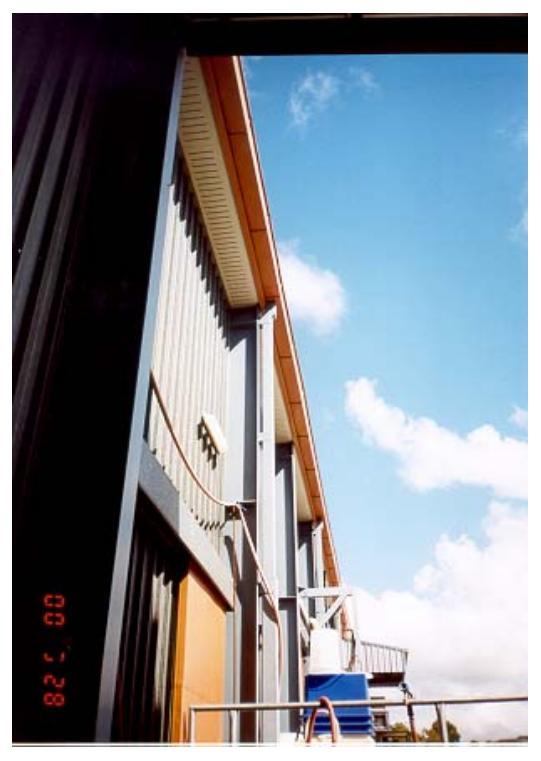
Photograph 10:

Asbestos cement eaves lining along the western wall of the Meat Research Laboratory.

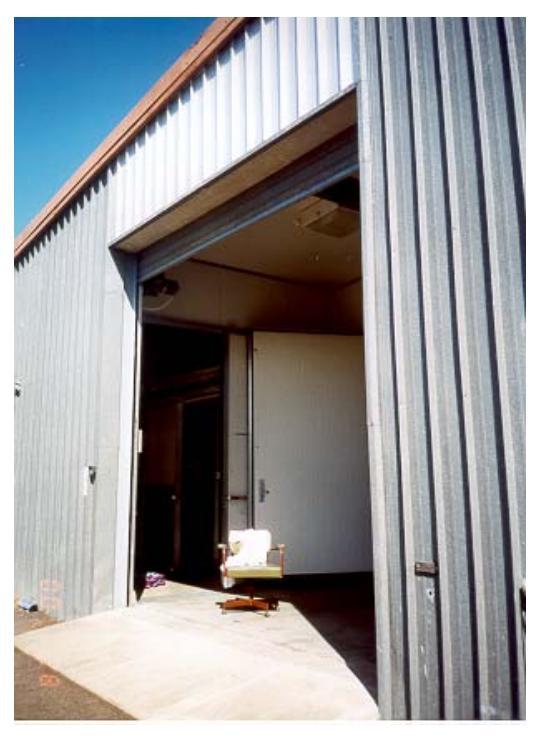
Photograph 11:

Asbestos cement infill panel above the roller door on the northern side of the northern side of the Meat Research Laboratory

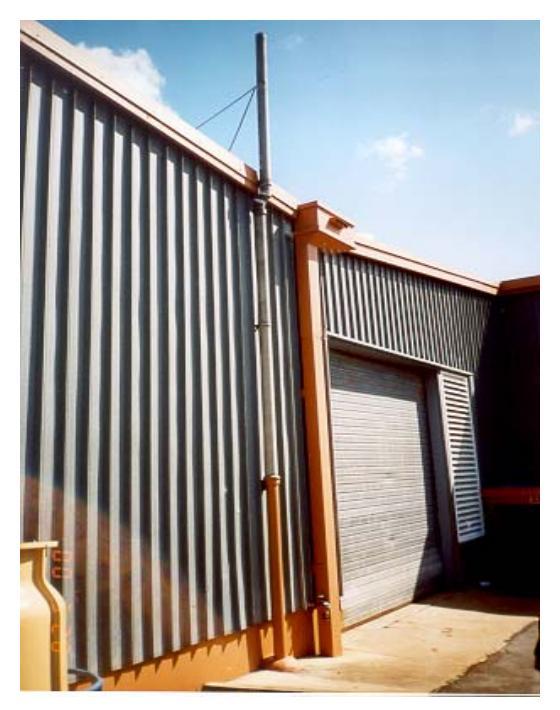
Photograph 12:

Asbestos cement flue pipe on the northern side of the Meat Research Laboratory

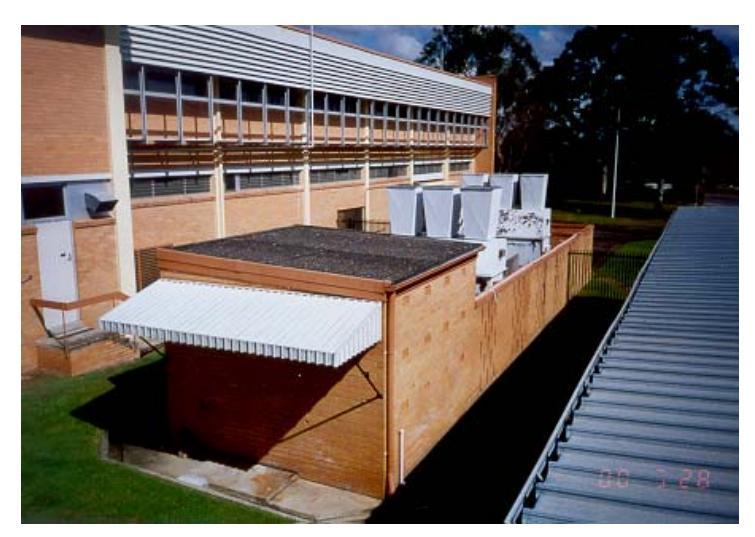
Photograph 13:

Asbestos cement roof and associated capping of building E-Solvent Store.

- 3. Remove the asbestos gauze mats from the laboratories and replace with a non-asbestos alternative;
- 4. Encapsulate the asbestos roof and associated capping of Building E Solvent Store to prevent further deterioration;

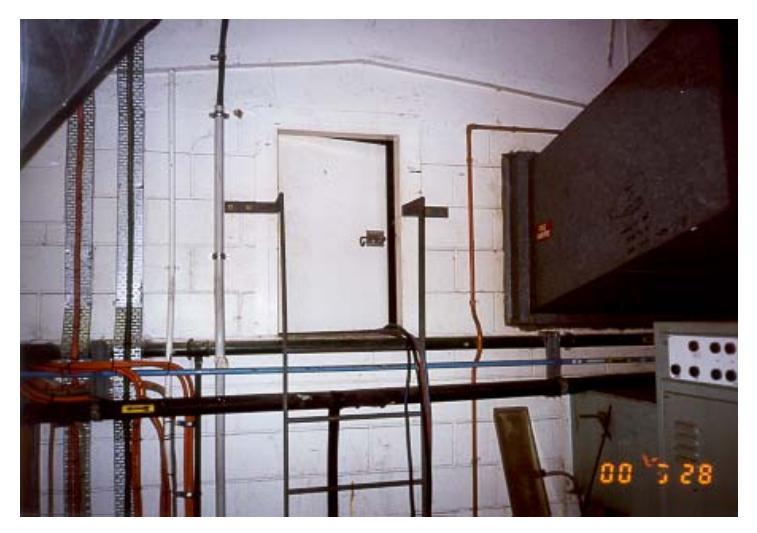
Photograph 14:

Fire door between the mezzanine level of the plant room and the roof top of industrial freezers, in the Meat Research Laboratory.

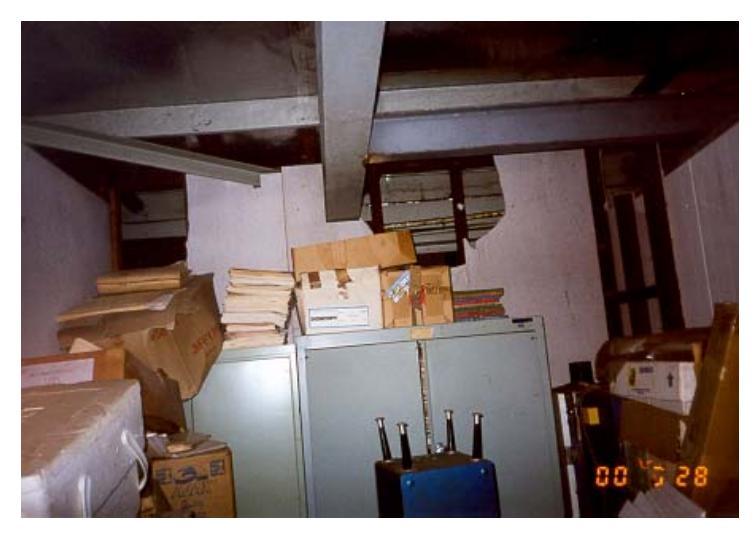
Photograph 15:

Severe damage to the western wall of the store area above the office/laboratory in the Meat Research Laboratory

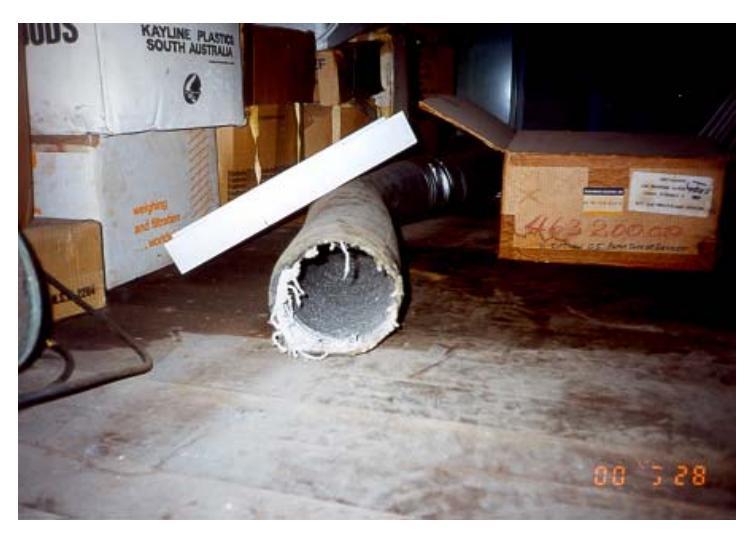
Photograph 16:

Asbestos rope insulation inside redundant piece of flexible ducting in the store area above the office/laboratory in the Meat Research Laboratory.

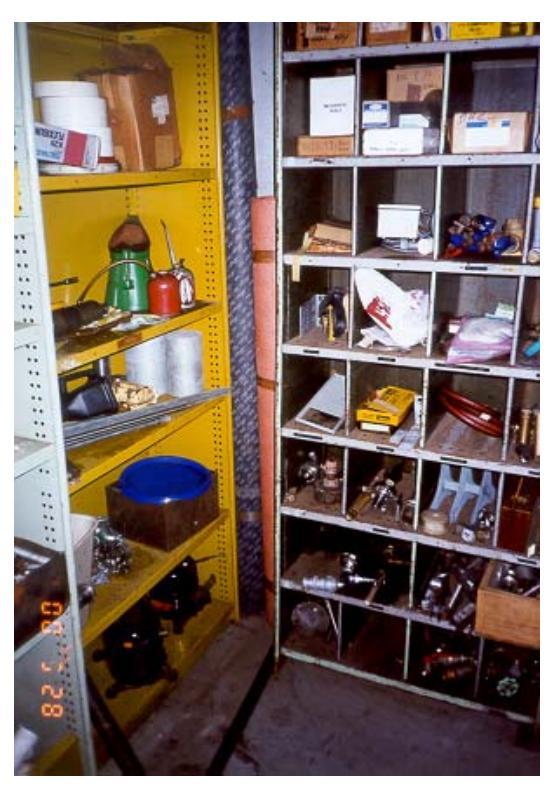
Photograph 17:

Stored gasket roll in the south west corner of the workshop store.

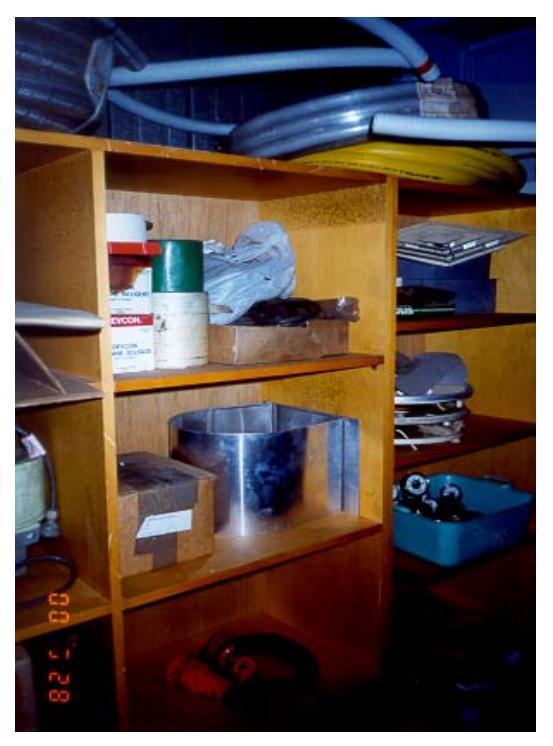
Photograph 18:

Asbestos gasket stored on top shelf along the eastern wall of the workshop store.

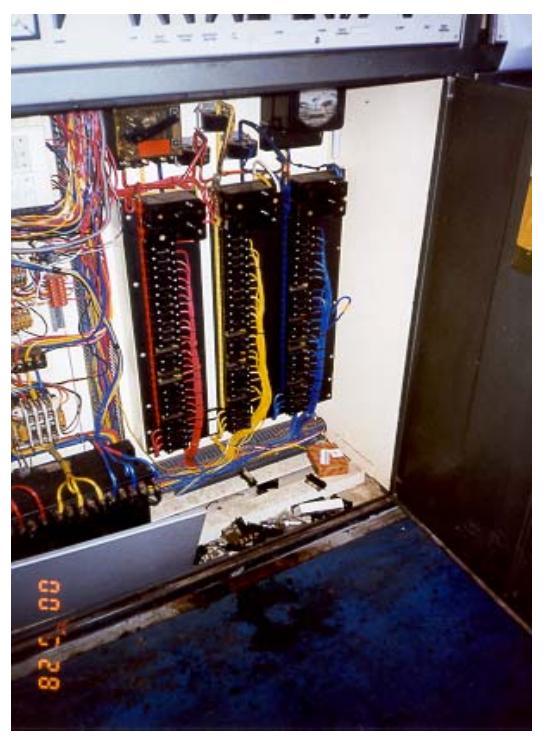
Photograph 19:

An electrical maintenance board to the brine cooler switchboard in the brine cooler switchboard in the plant room of the Meat Research Laboratory. It is thought that it may contain asbestos.

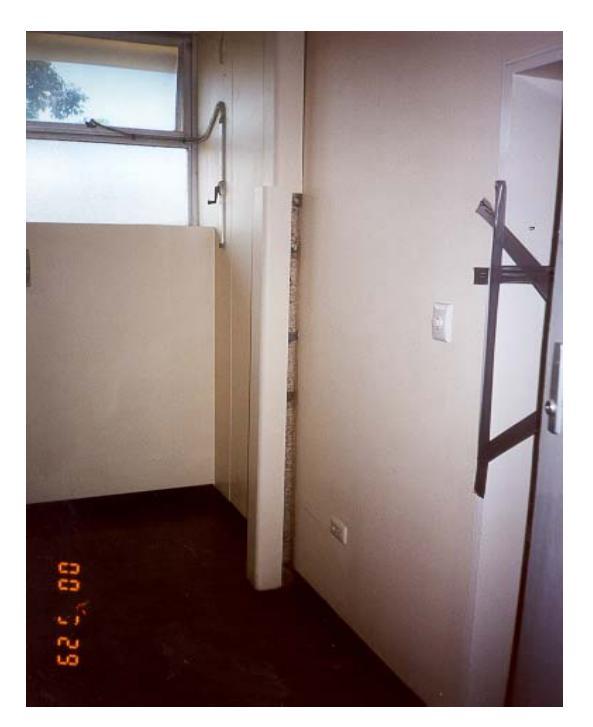
Photograph 20:

Asbestos rope lagging around flue pipe in male toilet on level 2 of Laboratory.
