# GUNGAHLIN HOMESTEAD PRECINCT

## Heritage Management Plan

13081  
**ISSUE 9**  
4 July 2014  
**FINAL**

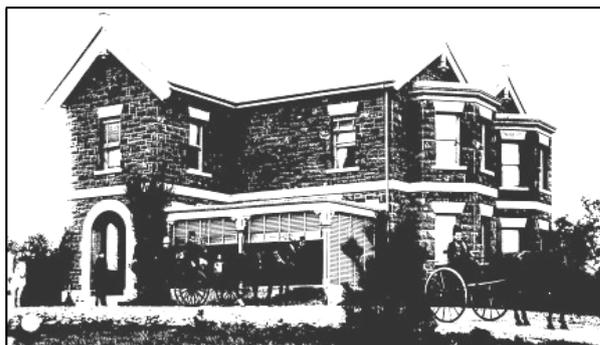
**Figure 07: View of House from South West c1890**

On the outside, the new wing of the house was coursed, rough faced sandstone. This stone may have been quarried from Black Mountain. Prominent on the south face were the two large bays above which rose gables, tipped with ornate finials (see Figure 7).

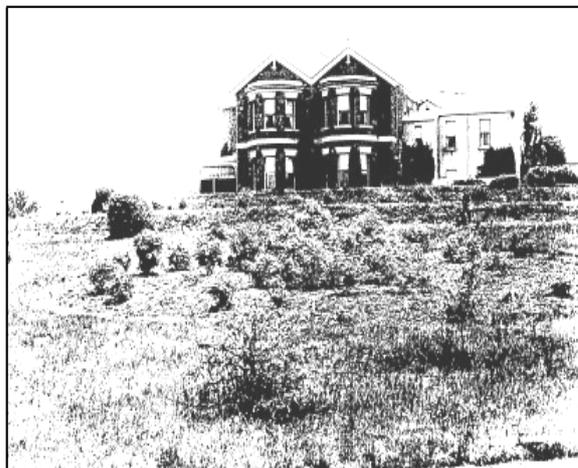
**Figure 09: View of House from South c1890**

The joining block was either unpainted or painted in an off-white colour. Many pipes were wall mounted on this joining block. In the front of the joining block there was a lattice screen. Some distance in front of the main house was the rose garden (see Figure 9).

If Building 006 to the south of the Gungahlin Homestead ever becomes redundant and removed it is recommended that the Victorian garden character of terraces and roses/shrubs seen in the c1890 photograph (Figure 9) be reinstated. The existing mature *Pinus canariensis* and *Cedrus deodara* in the courtyard south of Building 006 would make a fine setting for such a recreated Victorian garden.

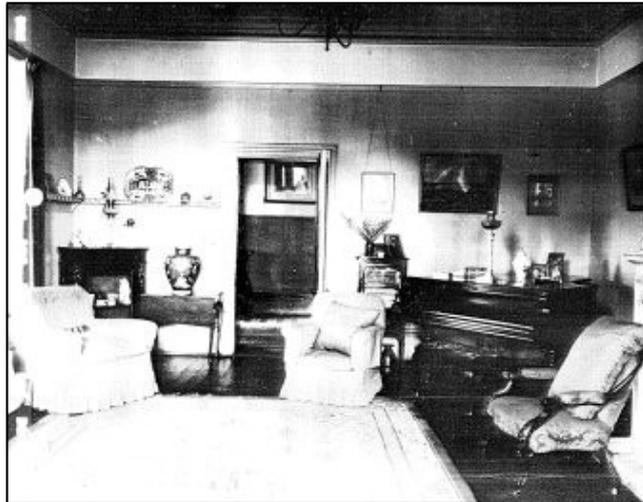
**Figure 13: Drawing Room in the 1930s**

In the drawing room, above the picture rail was white painted. The ceiling cornice and wall below the picture rail were painted a mid-tone colour. Curtains were hung off large timber curtain rods.

The hall was redecorated such that an imitation brown wood paint/wall paper was applied as a dado to the walls (see Fig 13). On top of this it was trimmed with a small bead. Above this was a lighter wallpaper.

Throughout the house cedar picture rails were installed. In the drawing room and bedrooms the rail was painted, elsewhere it was stained (see Figure 13 and 14). Staff toilets were installed in the eastern ground floor store

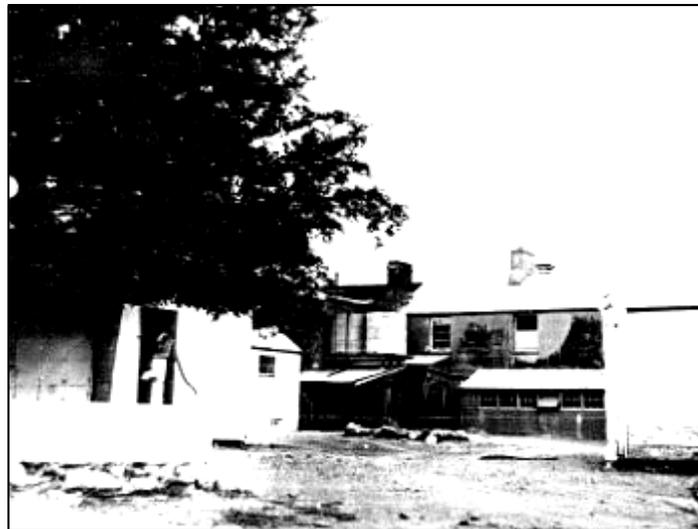
**Figure 15: Back Court Yard in the 1930s**

Outside a number of other changes had also taken place. A large water tank had been raised on a timber stand to the south of the joining block. Over the scullery two water tanks were mounted on a timber platform (see Figure 15).

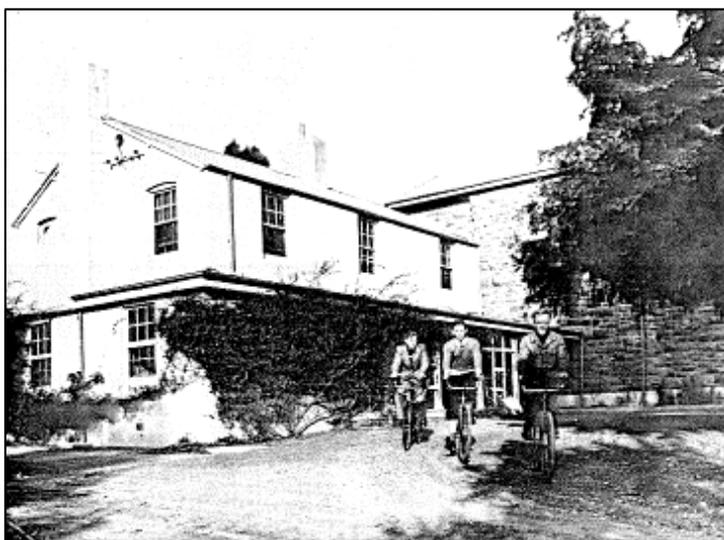
**Figure 16: 1860s Wing, c1950s**

As part of the renovations and maintenance on Gungahlin, the Homestead was painted externally; (see Fig 16) the 1860's house, the lintels, sills and stringcourse on the 1883 house. The strangers' bedrooms had been rendered and painted in the same style as the Davis house. Flyscreens had been fitted to the windows. The brick coursing on the chimneys had by this time been removed and the chimneys repaired. The rain heads on that part of the house had also been removed. A door had been put through to outside form the scullery and a window put in the north wall of the scullery.

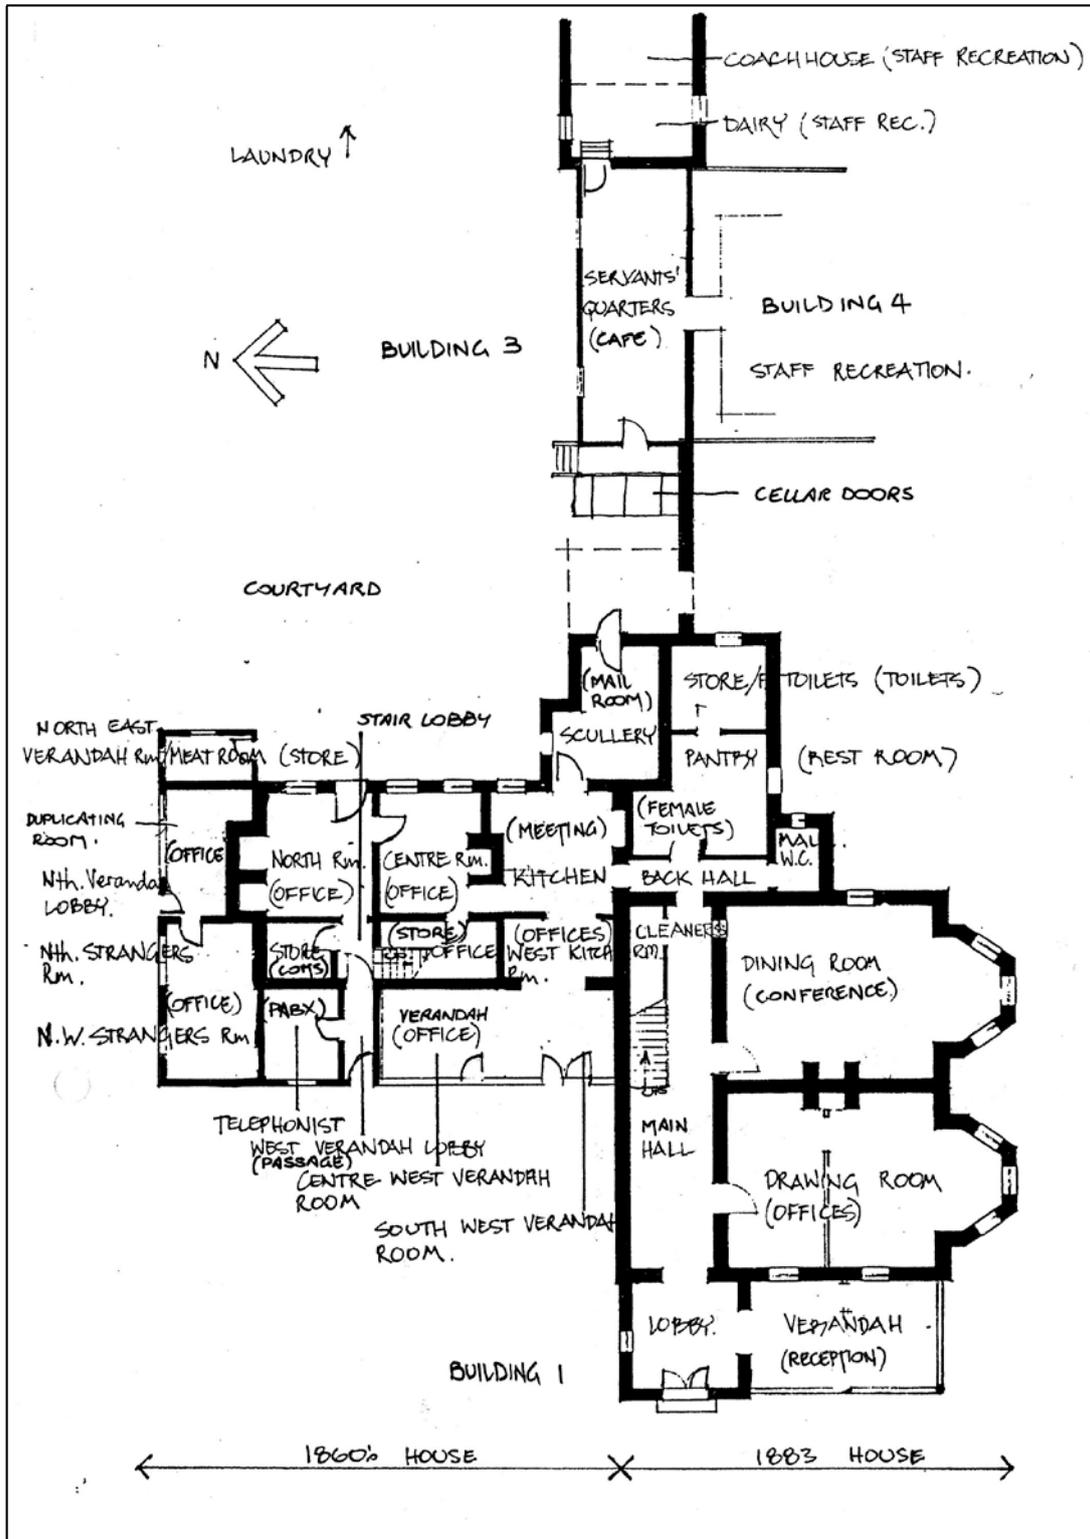
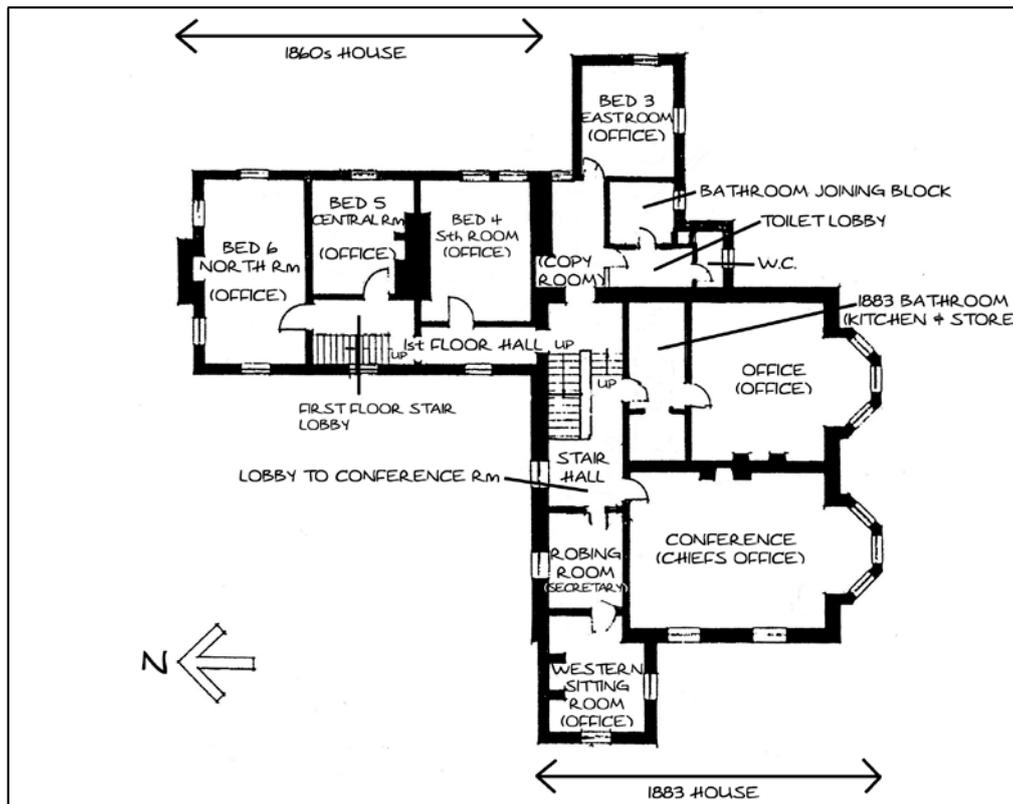
Floor plans of Gungahlin Homestead in 2004 are shown in Figure 27 and 28.

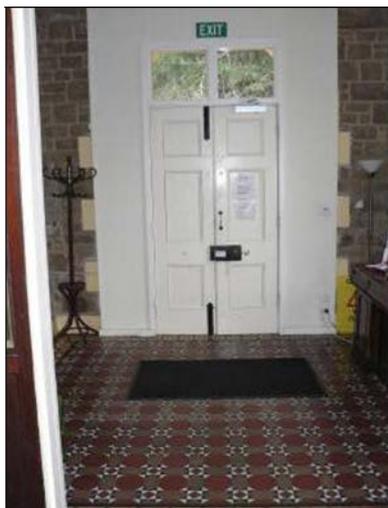
**Figure 29: Lobby Floor**

**Floor** – The floor is decorative mosaic tiles. There are some loose tiles and minor loss of grout. The walls have a 200mm high concrete skirt painted cream (see Figure 29).

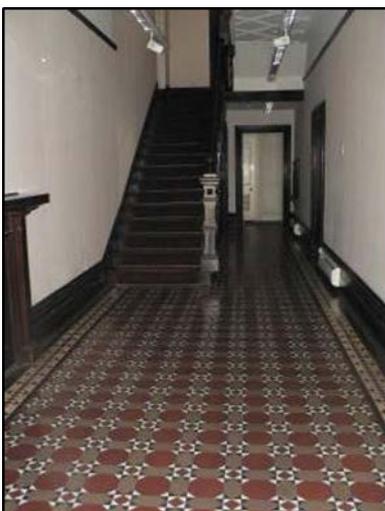
### **Figure 30: Main Hall**

**Walls** – All walls are wallpapered up to a stained cedar picture rail, above which is white painted (see Figure 30). The wall paper is in good condition but lifting in several locations (along joints).

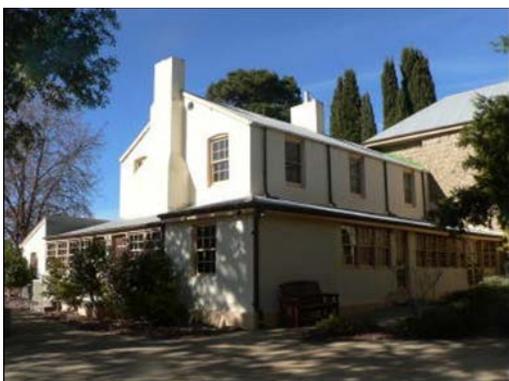
**Figure 31: 1860s Wing from West**

The two storey section has rendered and paint finished masonry walls. 12 pane double hung sash windows are located symmetrically in each facade. The roof of the main building and verandah has been replaced with corrugated iron. The iron was once painted green but this has nearly all peeled away (Figure 31 and 32).

On the North West and north east corner of the verandah are two rooms with rendered and painted masonry wall. (During restoration works in the 1990s the walls of the west room were found to have glass bottles laid horizontally as a filler within the wall. This most unusual technique may indicate a lack of readily available masonry building materials or finance at the time of construction, the bottles being used to stretch the resources). There is some recurring cracking in the northwest corner.

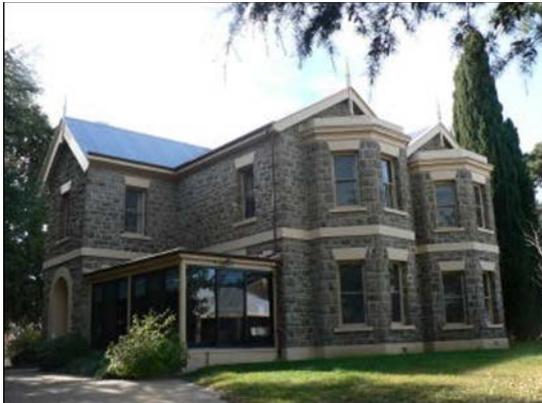
**Figure 33: 1883 Wing from South West**

The 1883 wing is larger and more dominant than the 1860s wing. It is constructed with sandstone walls with a small protruding entry wing on the west and double bay windowed gabled wall to the south (Figure 33).

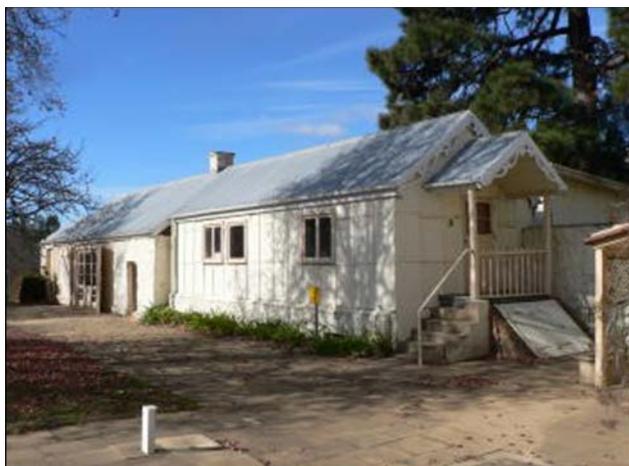
**Figure 35: Servants' Quarters and Coach House**

The walls and hipped roof of the Servants' Quarters are clad in a rare profiled metal pan tile system which is paint finished. Some of the tiles have been damaged but the building cladding is generally sound (refer Figure 35). The roof is corrugated galvanized iron. Gutters on both sides are full of pine needles and leaves.

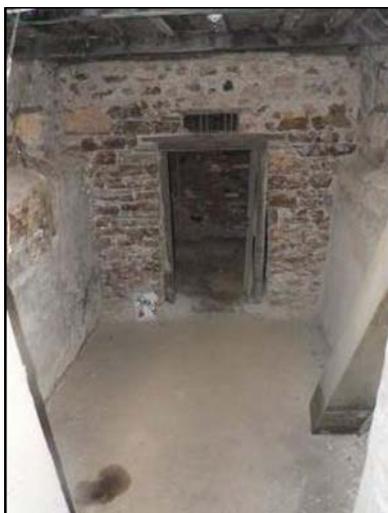
**Figure 36: Cellar Interior**

**Ceiling** – There are only the floor joists and boards. They vary in age and soundness. The Servants' Quarters verandah is fair while the quarters themselves have new boards and some new joists. There is a significant crack in the bearer above the entrance stairs which should be inspected for structural integrity as it supports the wall above.

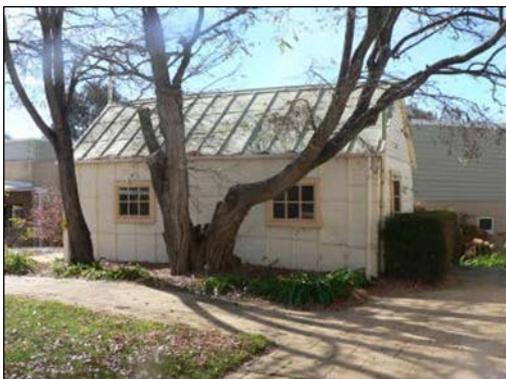
Figure 37: Herbarium from North West

The herbarium is a simple rectangular building with hipped roof (see Figure 37). The stud framed walls and roof are clad in similar metal pans to the Servants' Quarters.

The building has been restored and conserved since 1982 and appears sound with finishes in fair condition.

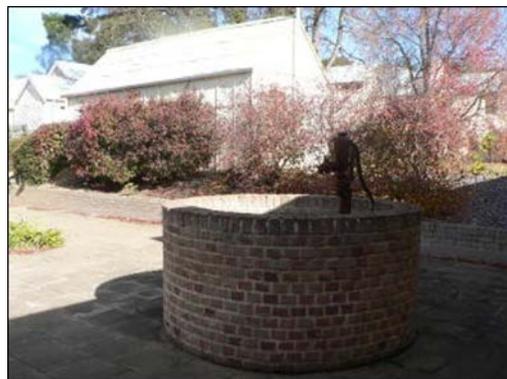
Figure 38: Reconstructed well  
Adjacent Herbarium

Adjacent to the north east corner of the building within the new north south path is the reconstructed original well and Horse Trough (Fig 38). Gutters are full of leaves and pine needles.

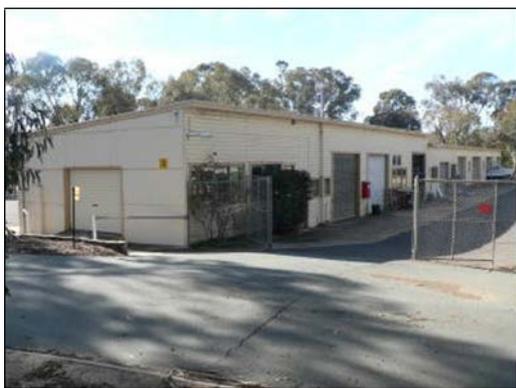
**Figure 39: Field Stores/Workshop**

The only surviving building of this period is the Workshop Field Stores (Building 012), the first stage of which was completed by CSIRO staff in 1956. The building has since been extended twice but each time maintaining the simple plan, roof form and materials of the building (see Figure 39).

The Workshop building is a timber framed structure with a suspended timber floor on brick piers. The walls are clad principally in fibro (asbestos) sheet with some weatherboard cladding on south wall. The building has a corrugated iron clad skillion roof. The building is still actively used and generally fair to good condition.

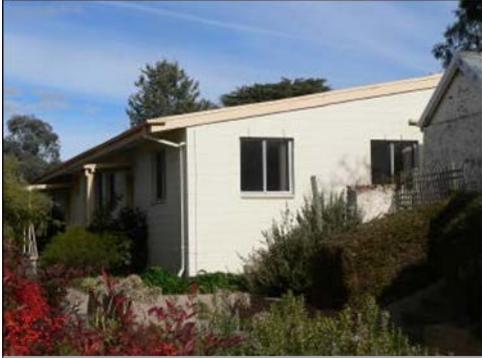
**Figure 43: Global Change Laboratory**

With Building 018, this was the first specific building constructed to accommodate a research program. It is a single level concrete block building located near the south wall of the Servants' Quarters Building (see Figure 43). The building's exterior shows little evidence of change however the interior fitout may have changed with time. The building is in good condition.

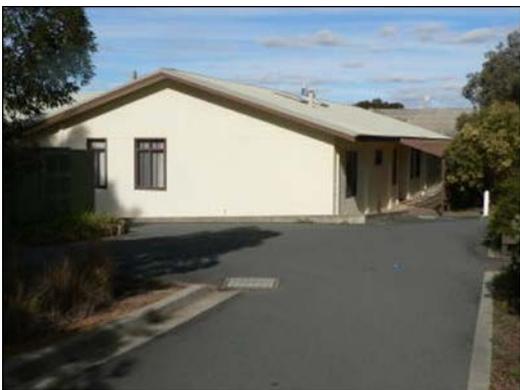
**Figure 44: ANWC Collection Building**

In the 1970s, the CSIRO erected the first stage of the building which now houses the Australia National Wildlife Collection. The building follows the vein of buildings erected on site in the 1960s. It is constructed on a concrete slab with painted concrete block walls and low pitched corrugated Colourbond roof. The building is simple and functional in design (see Figure 44).

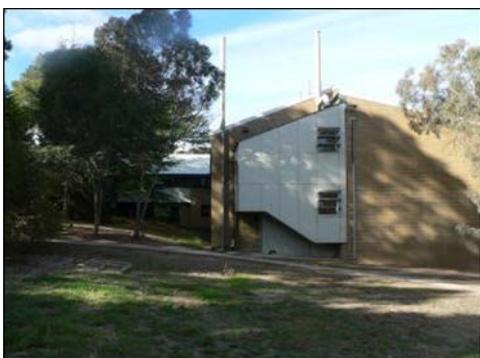
Figure 45: Building 032

The 1980s saw two major research buildings constructed and the first (and last) two storey CSIRO buildings. Building 032 which was constructed in 1980 was the first purpose built laboratory building on site. It comprises two wings set in an L-plan with the south wing containing laboratories on both levels and the east wing only on the lower level. The upper level east wing contains staff offices, and a large seminar room (see Figure 45). Part of the original carriage loop has been obstructed by the construction of the seminar room.

The building is constructed in economical material of the time, with coloured concrete block walls with contrasting painted compressed fibro cement sheet infill panels. The building is simple and functional in design with no notable aesthetic or technical characteristic. It is the second largest building in floor area on site (Building 044 is the largest).

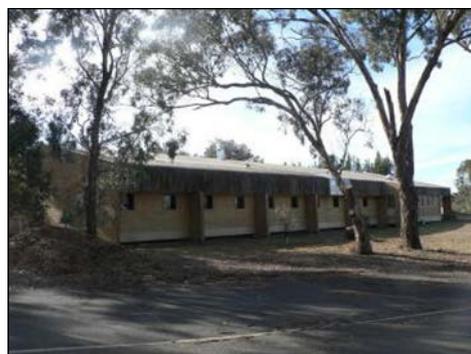
Figure 46: Animal House Complex

In 1983 the Animal House Complex (Building 031) was constructed adjacent to the National Wildlife Collection building. Building 031 is constructed of similar materials to Building 032 but has a hipped corrugated asbestos sheet roof. The building is cut into the fall of the site but remains a prominent visual element due to its large singular roof and minimal wall fenestration (see Figure 46). A garden of semi mature native shrubs planted against the building on three sides provides some screening.

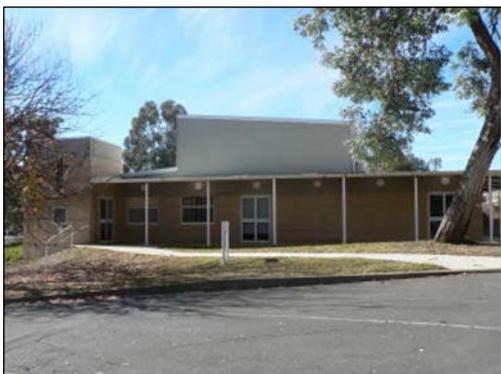
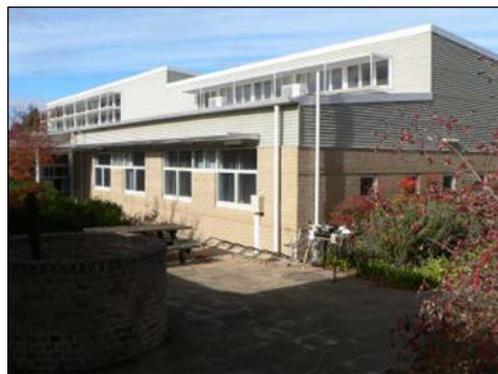
Building 044 accommodates a new conference facility, laboratories, staff offices and facilities. Building 045 was purpose designed as the new Division Library. Both buildings are in good condition with minor weathering externally.
