CSIRO's Radioactive Waste at Woomera Test Range

CSIRO is working to determine the best options to prepare waste material currently stored on Commonwealth land at the Woomera Test Range in South Australia for transfer and acceptance at the proposed National Radioactive Waste Management Facility (NRWMF).

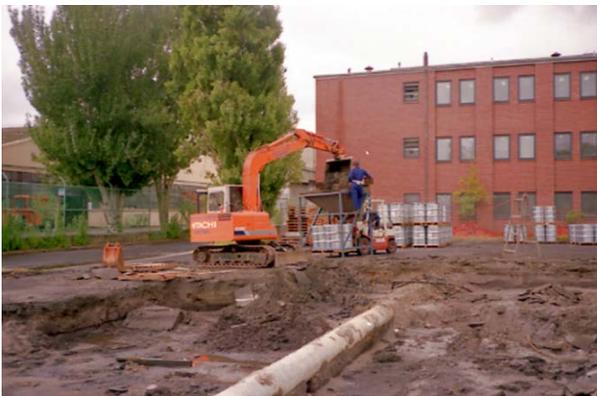
Removal of material from a carpark at Fishermans Bend

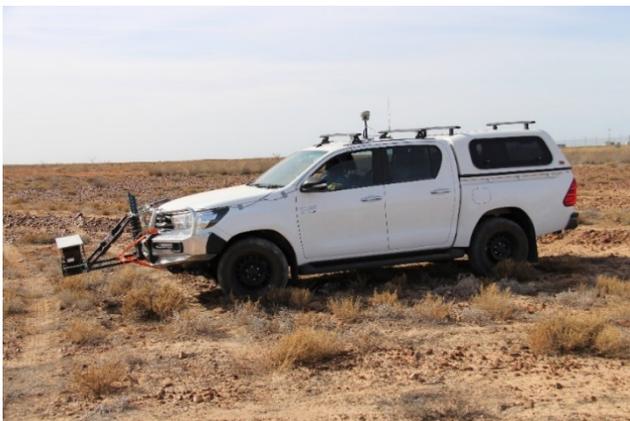
Gamma radiation survey for environmental baseline (2018)

Latest testing shows that the material in storage does not present risks to worker safety or the environment. Measurements taken in May 2018 show that radiation levels adjacent to the storage are typical background levels found in the natural environment in Australia, such as rocks and soil.

CSIRO has worked with the Australian Nuclear Science and Technology Organisation (ANSTO) to establish a comprehensive environmental baseline radiation level for the location, including measurements of air and the soil, to check that no contamination has occurred from waste storage.

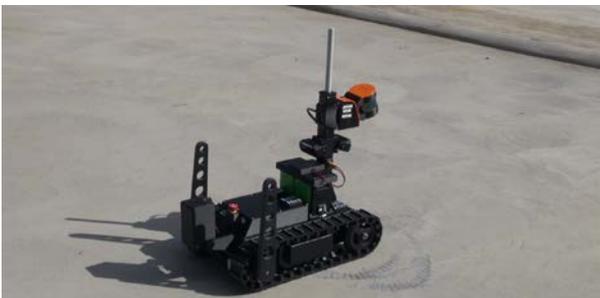
ATLAS robot built to take measurements on top of drums

CSIRO has been using robots which can travel under and on top of the tightly stacked storage drums to better understand the physical condition and contents. The painted or galvanised drums are just over half way through their expected useful life of around 40 years. The robots are able to travel between the drums to areas which cannot be reached by people, without disturbing the drums themselves, to measure radiation dose and inspect drum condition.

Robotic work also indicated most drums are not showing above-background levels of radiation, and where radiation was detected it is at low levels at 10 microsievert per hour or less.

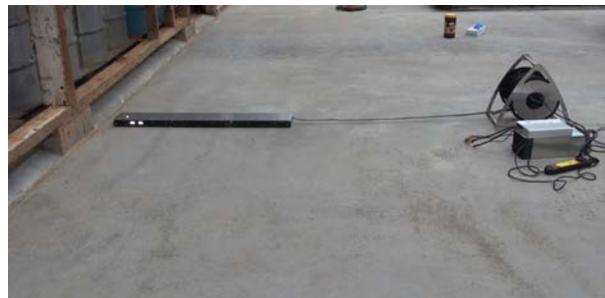
PEABODY robot travelling under drums to take measurements

The robot's visual inspection of drums indicated that they are intact, appear in good condition and are showing no visible signs of leakage.
